DOT/FAA/AR-98/22

FAA T53-L-13L Turbine Fragment Containment Test

June 1998

Final Report

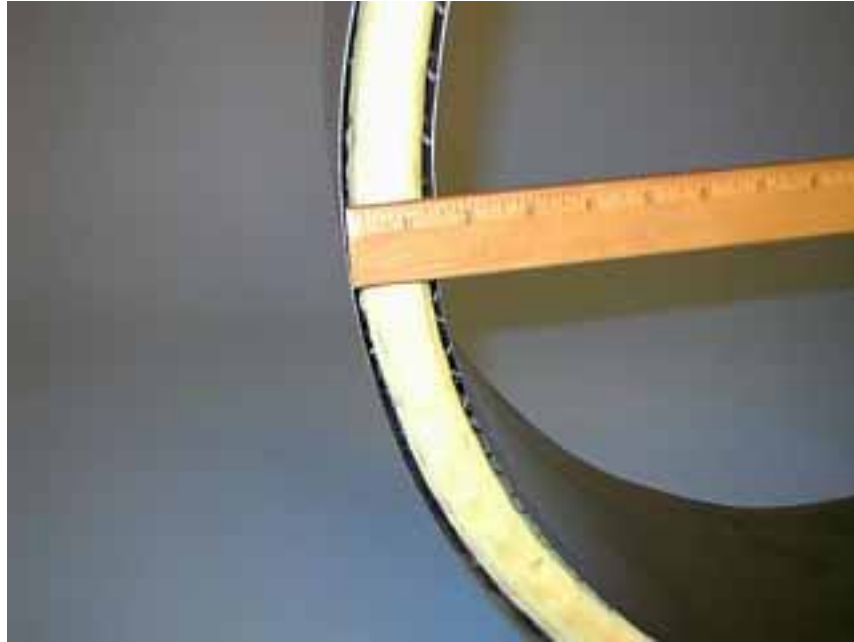
FIGURE 1. CONTAINMENT RING SECTION

The containment ring was developed and fabricated by Pepin Associates Inc. The ring was fabricated with a 0.014-inch titanium inner and outer sleeve. One-inch-thick Kevlar 29 ballistic fabric made up the primary structure of the containment ring. The ring was strengthened with titanium rods which were inserted through the fabric and laser welded to the inner and outer sleeves (figure 1). The ring weighed approximately 25 lbs. The containment ring was installed on the test engine and loosely connected to the engine case. The ring was centered on the second stage power turbine.

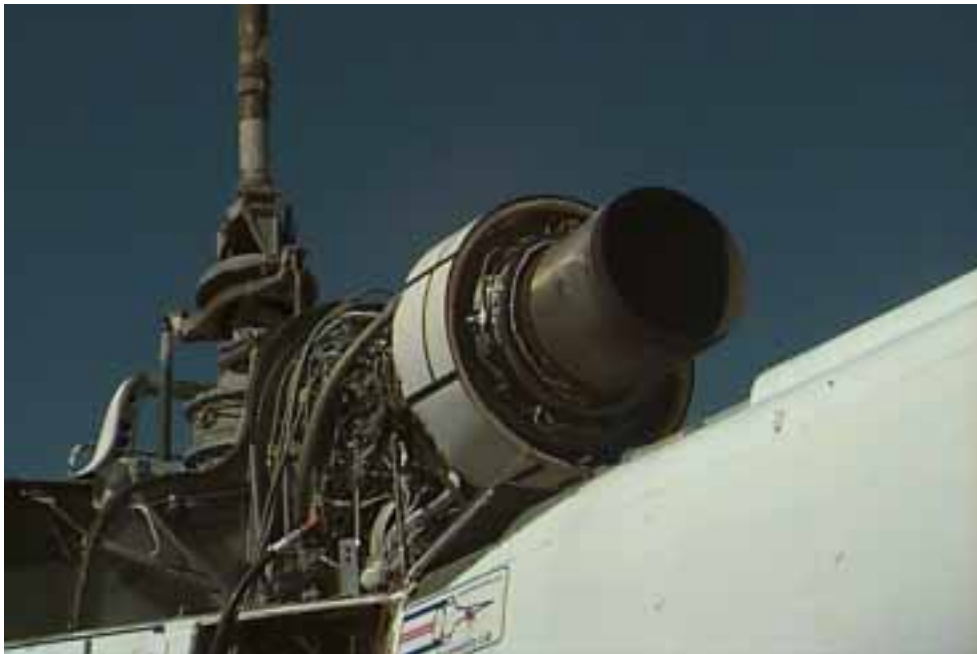
FIGURE 2. PRETEST INSTALLATION

The T53 engine was then installed in an UH-1 Huey helicopter (figure 2). The helicopter was mounted on two 2-foot-thick cement blocks and cabled down to three 1-foot-thick cement blocks (figure 3). The rotor head was removed to simplify the test setup and preparation. The engine was remotely started and operated. An emergency shutoff valve was located near the engine interface.

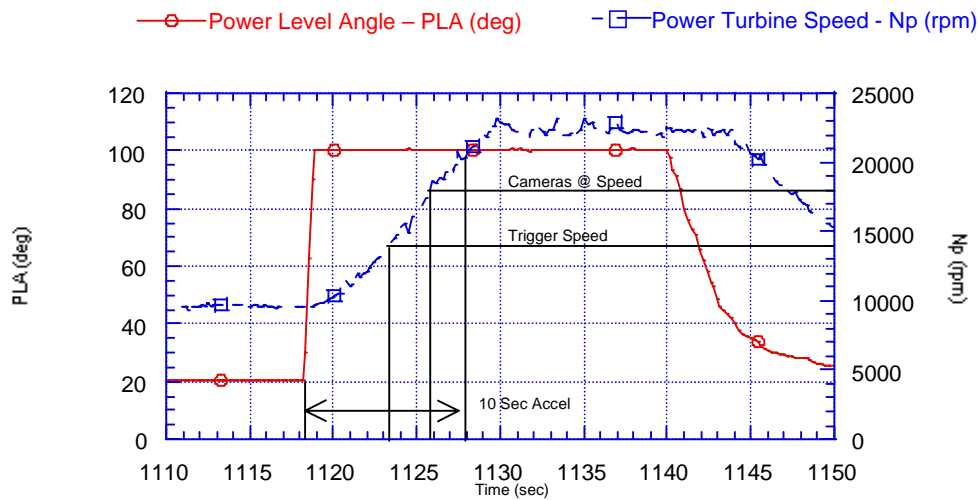
FIGURE 4. ENGINE ACCELERATION CALIBRATION

Even though the disk was notched, there was no way of determining exactly when or at what speed the disk would fail. To capture the event on high-speed film, a speed trigger circuit was used. There were approximately 8 seconds of film at a camera speed of 4000 pictures per second, 2.5 seconds of which were used as the cameras came up to speed. Prior to installing the test engine, a second engine was tested to determine the power turbine acceleration time from idle to maximum (figure 4). Multiple runs were conducted, and it was determined that the acceleration from idle to maximum was approximately 10 seconds. Idle speed was approximately 10,400 rpm and maximum was 22,500 rpm. Based on the engine acceleration times and the target rupture speed (20,400 rpm) and considering the camera time required to come to speed, a trigger speed of 14,000 rpm was chosen.

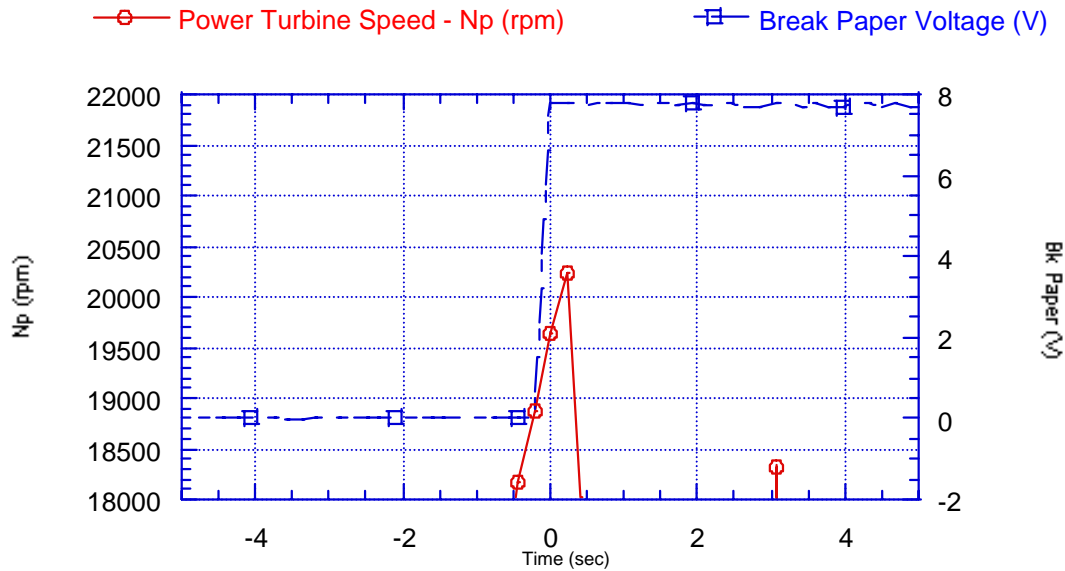
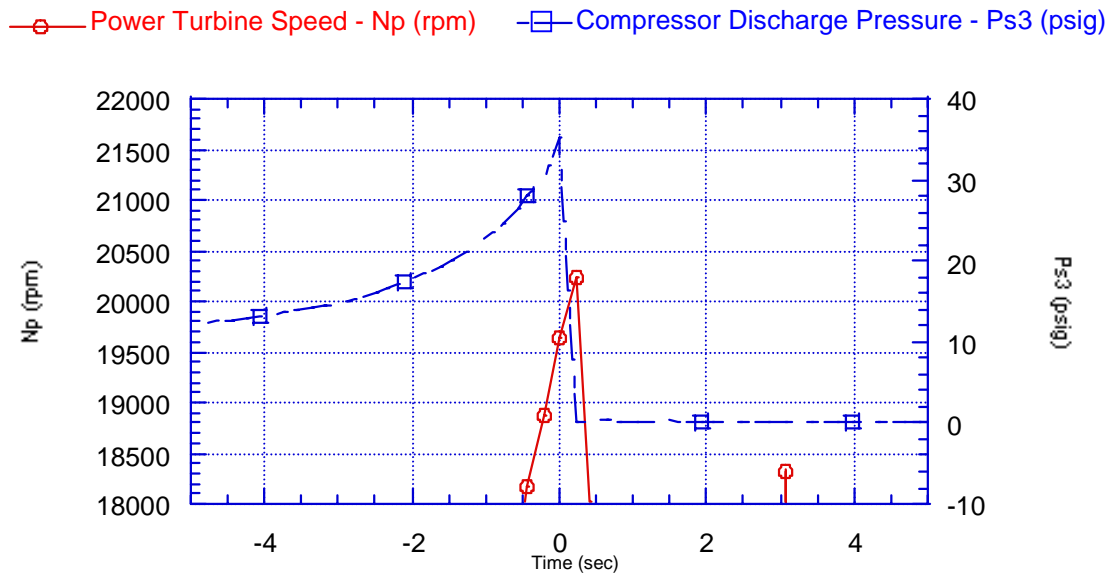
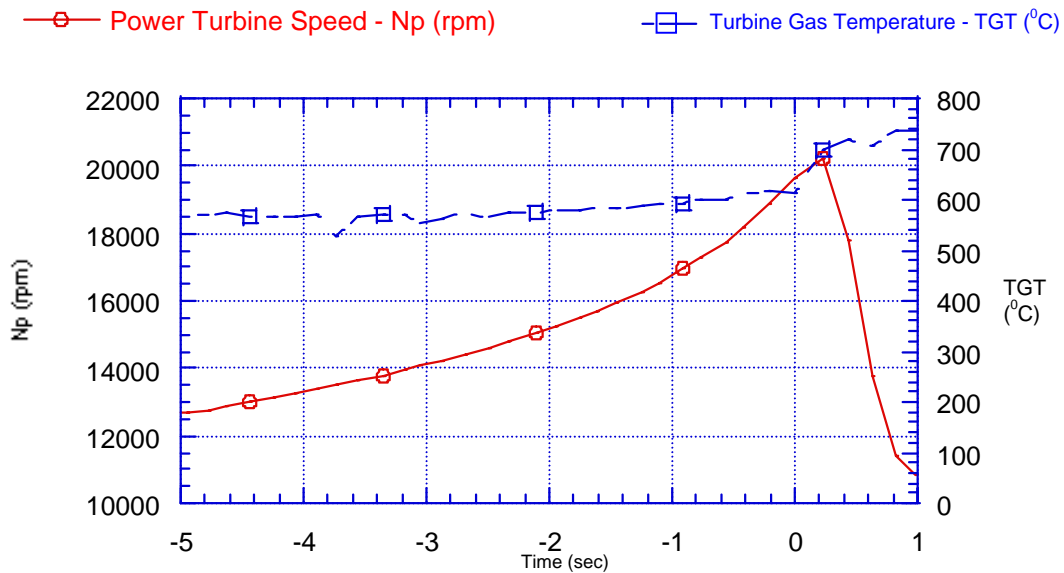
The test was completed as planned. The cameras were triggered as Np passed through 14,000 rpm. The disk released at 19,629 rpm. Test data are provided in figures 5 through 7. The disk ruptured into three nearly equal sections that were contained by the containment ring. The outer titanium shell split due to the tensile load resulting from the disk fragments pulling the Kevlar into a triangular shape. All three disk fragments penetrated the engine combustor case. The fuel lines located between the containment ring and combustor case were penetrated, resulting in a small fire. Secondary blade fragments exited the engine exhaust nozzle and a few fragments

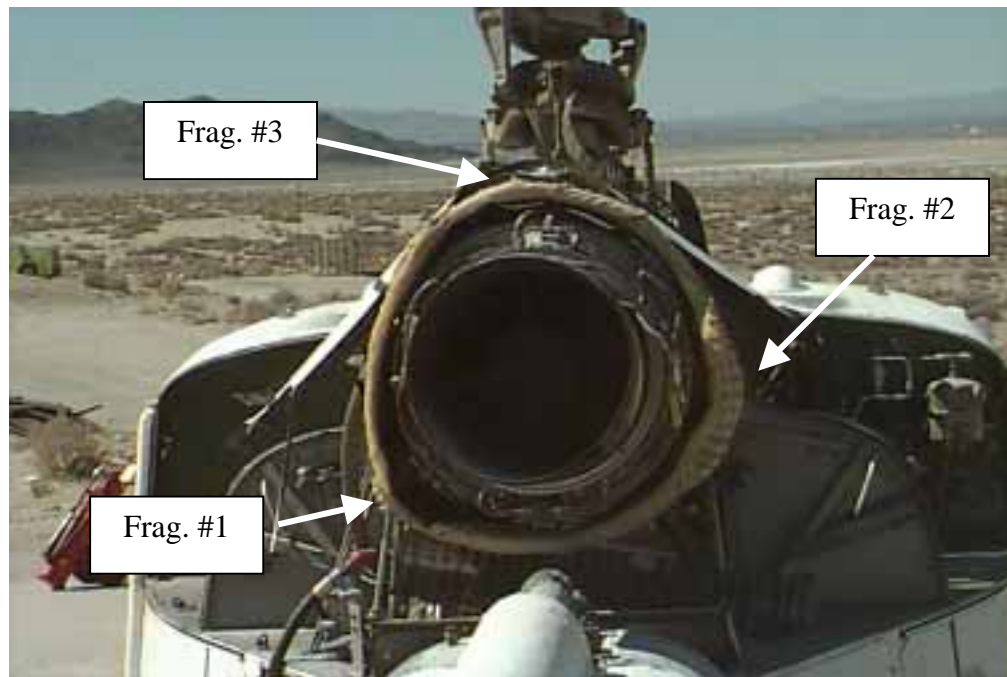
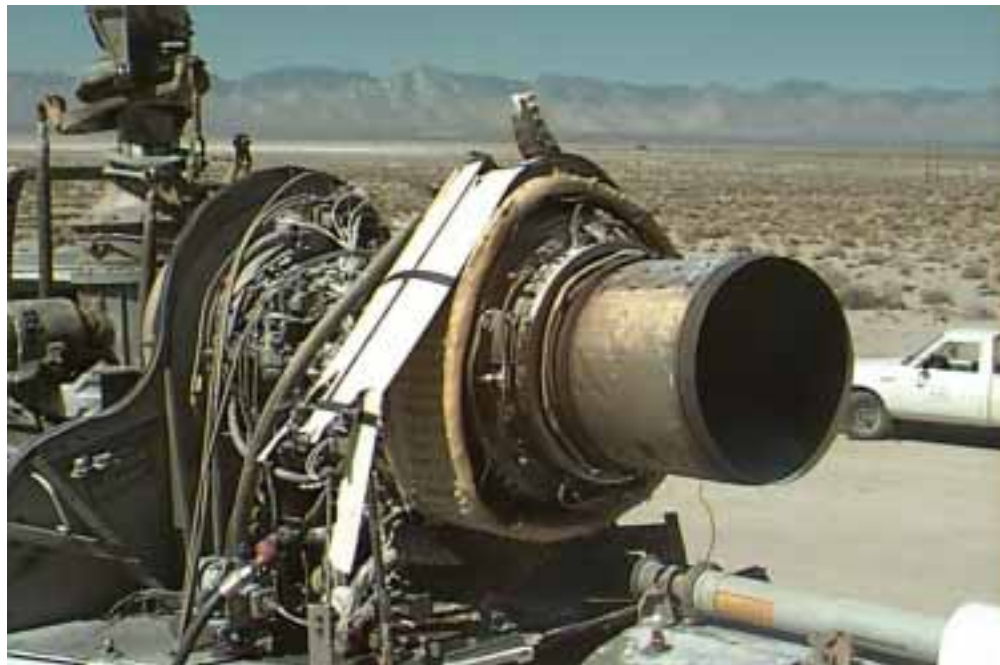
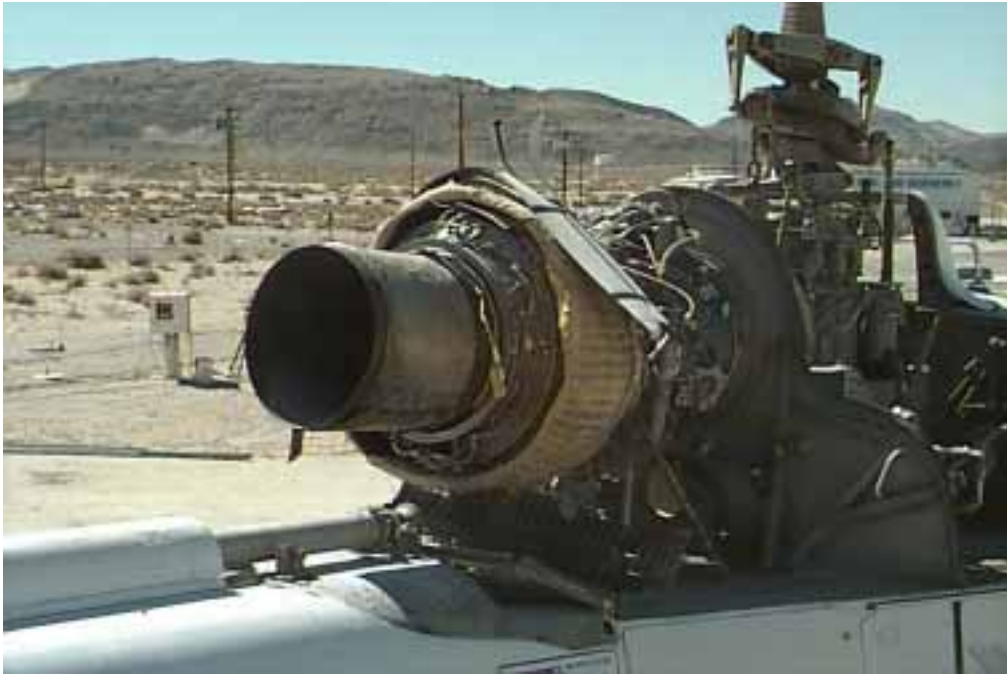
appeared to exit through the holes created by the disk fragments. These fragments were low-energy releases. Post event pictures are provided in figures 8 through 11.

The engine stayed within its mounts, with little apparent duress caused from the disk fragment energy being absorbed. The only noticeable sign of high vibration or loading was a broken throttle linkage.

All three fragments penetrated through the combustor case and were embedded inside the containment ring. Minimum interactions between the immediate engine components and fragments were observed.

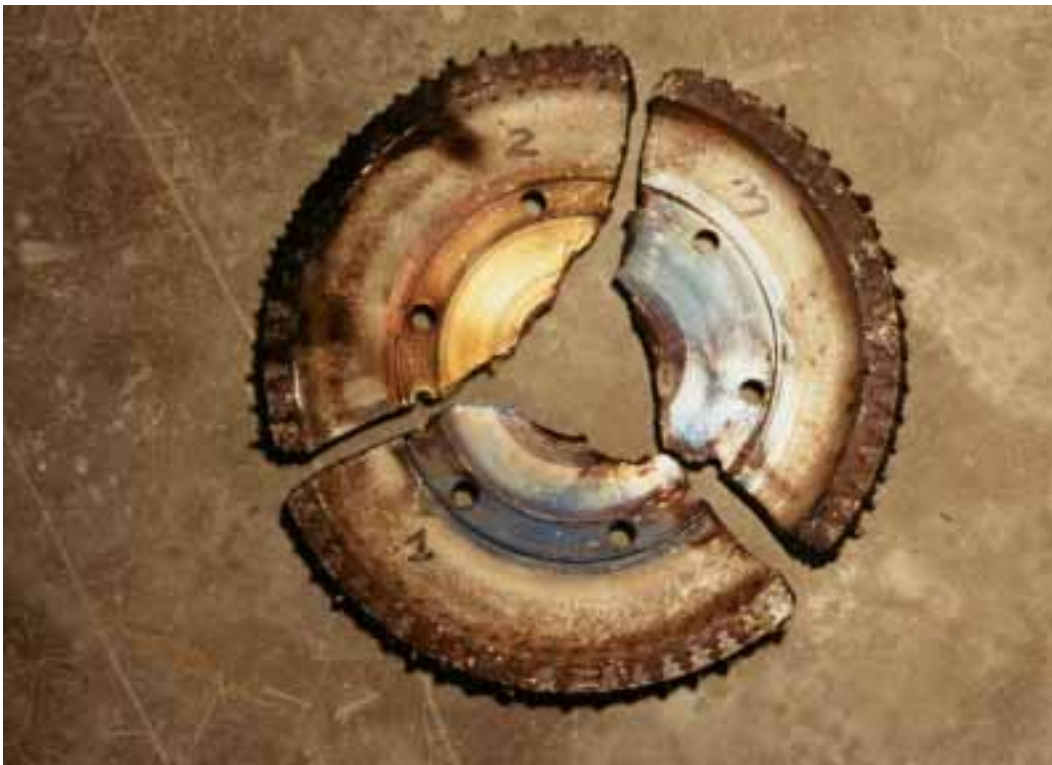
FIGURE 11. DISK FRAGMENTS

The disk fragments were recovered and weighed (table 1). The original weight of 10.8 lbs included blades which were broken off during impact. Approximately 2.65 lbs of debris was released.

Disk Fragment Number	Fragment Weight After Burst (lbs)
1	2.66
2	2.70
3	2.79
Total Large Disk Fragments	8.15
